## Specific Site Assessment for Coal Combustion Waste Impoundments at Minnkota Power Cooperative Milton R. Young Station

Center, North Dakota

June 2011  
Project 092884

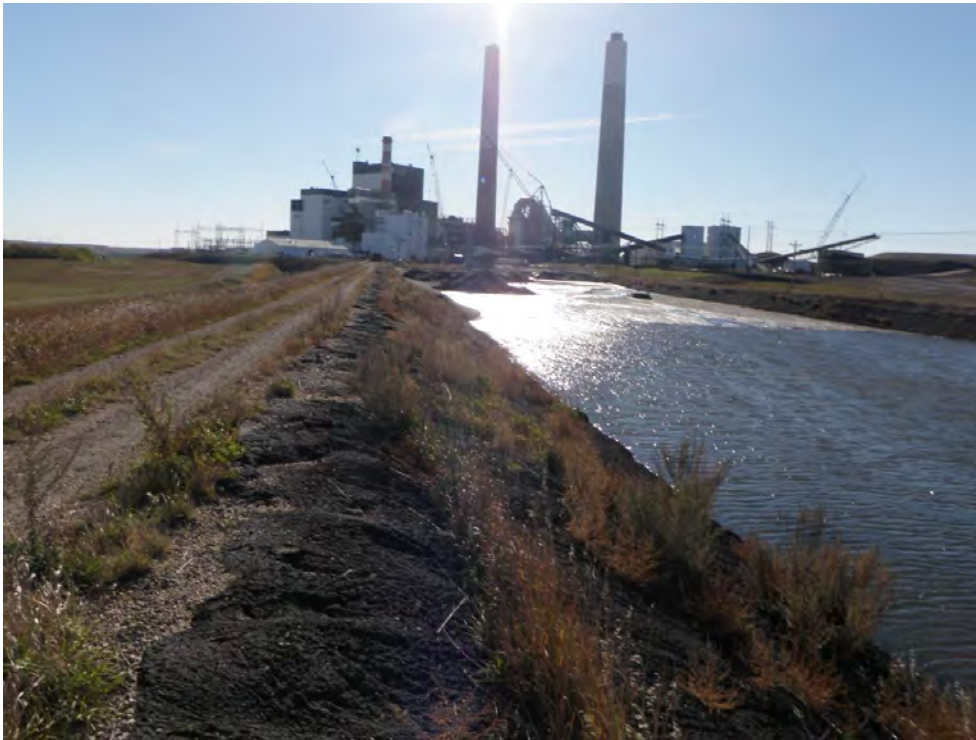
**Photo 1: Alternate Bottom Ash Pond – North dike upstream slope, looking east.**

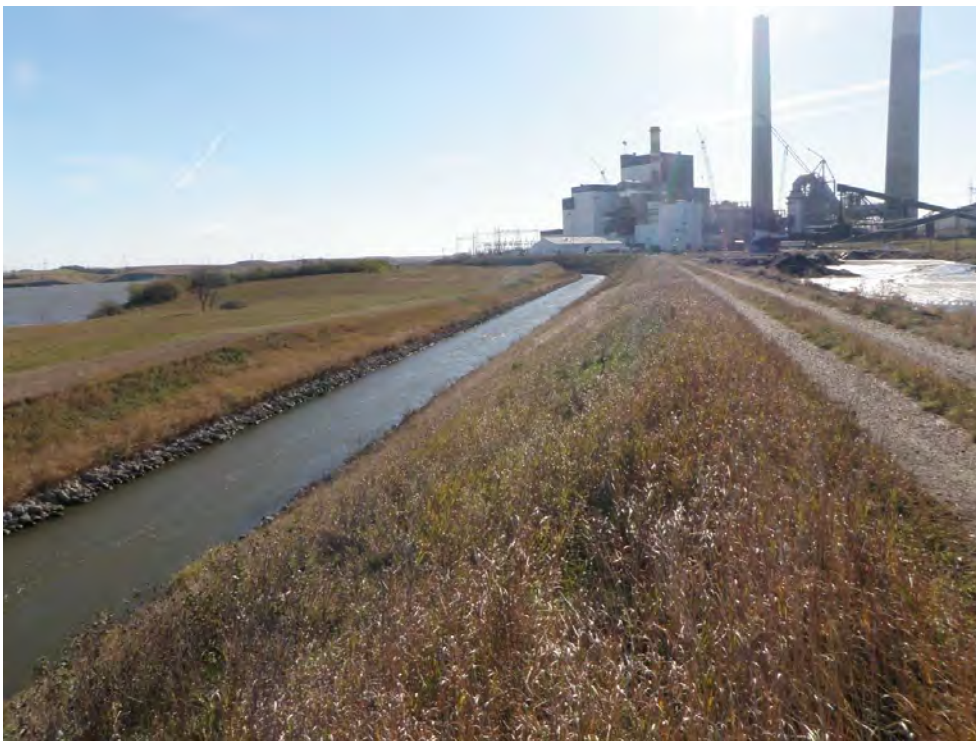
**Photo 2: Alternate Bottom Ash Pond – North dike downstream slope and cooling canal, looking east.**

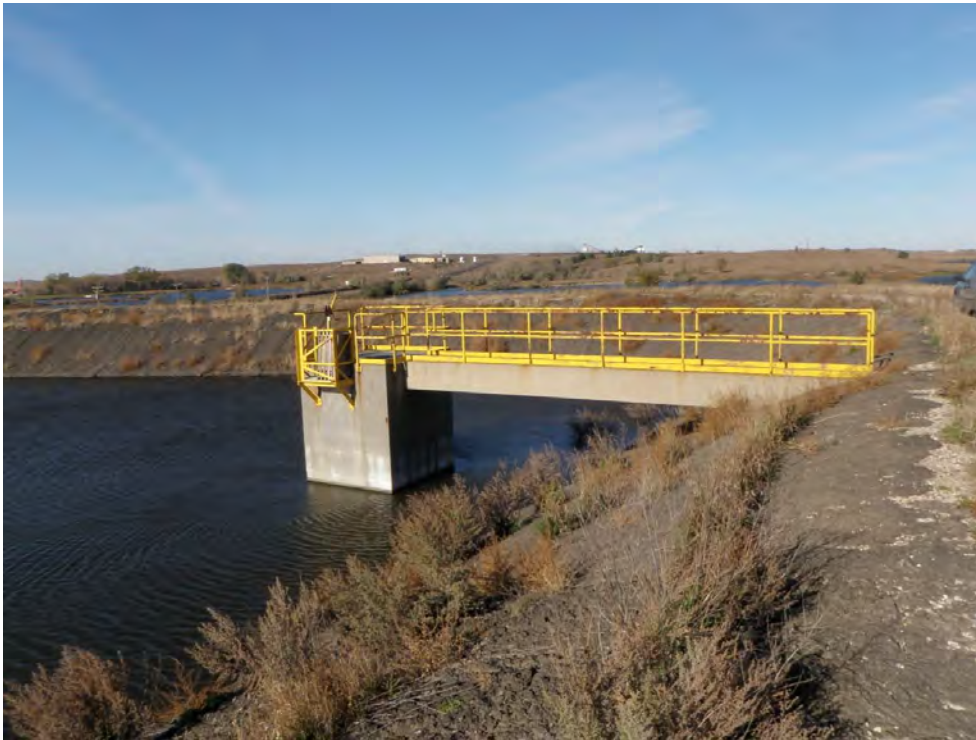
**Photo 3: Alternate Bottom Ash Pond – Stop log structure on north dike, looking west.**

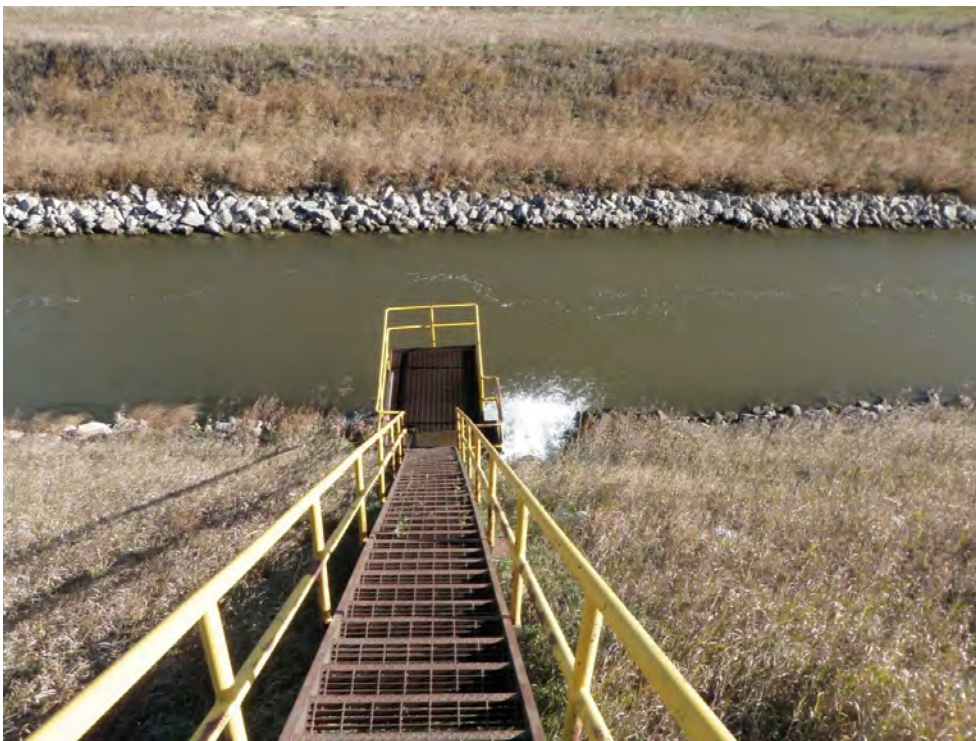
**Photo 4: Alternate Bottom Ash Pond – Outlet to cooling canal, looking north.**

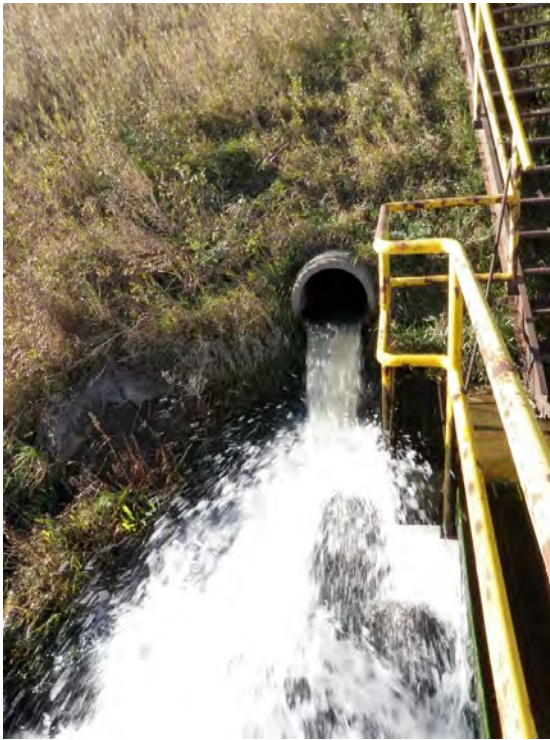
**Photo 5: Alternate Bottom Ash Pond – 18" diameter RCP discharge to cooling canal, looking south.**

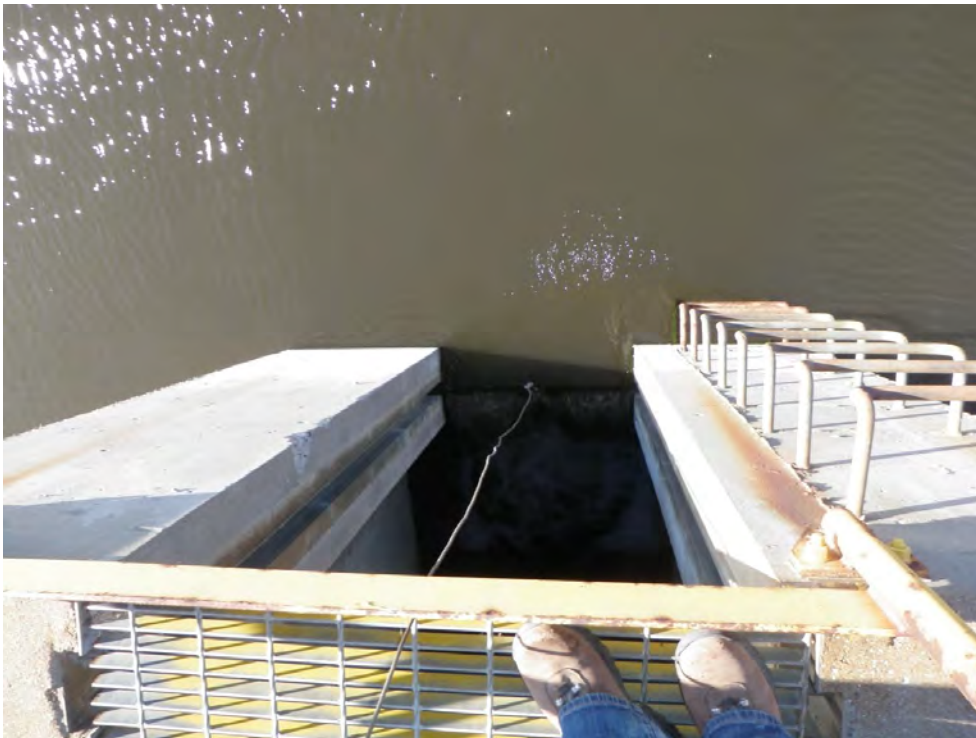
**Photo 6: Alternate Bottom Ash Pond – Stop log structure inlet.**

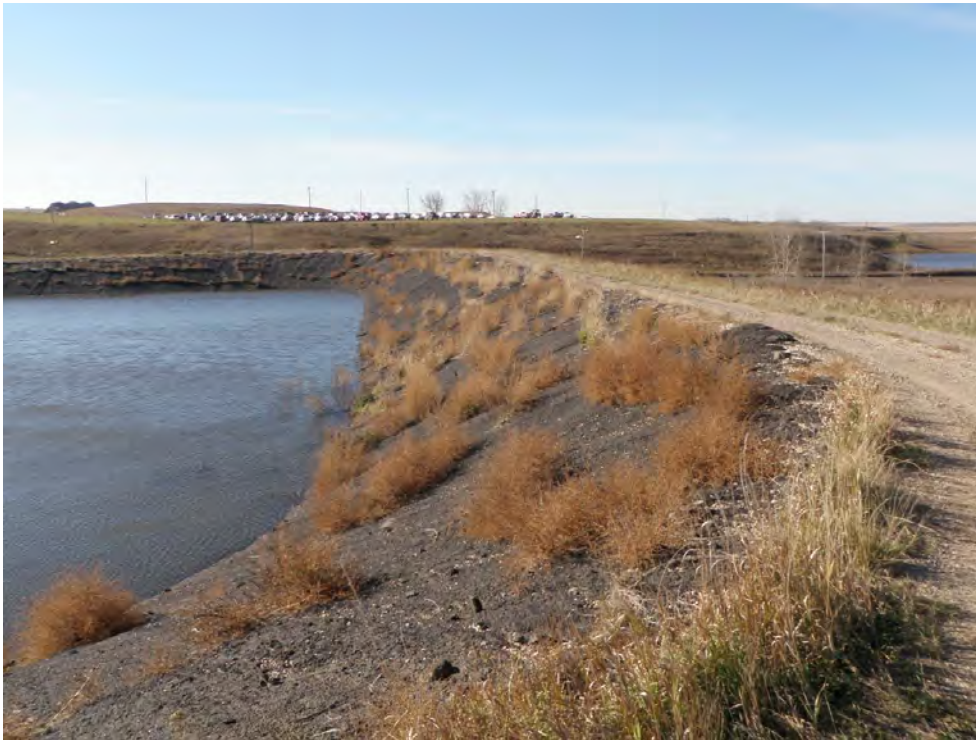
**Photo 7: Alternate Bottom Ash Pond – West dike upstream slope, looking south.**

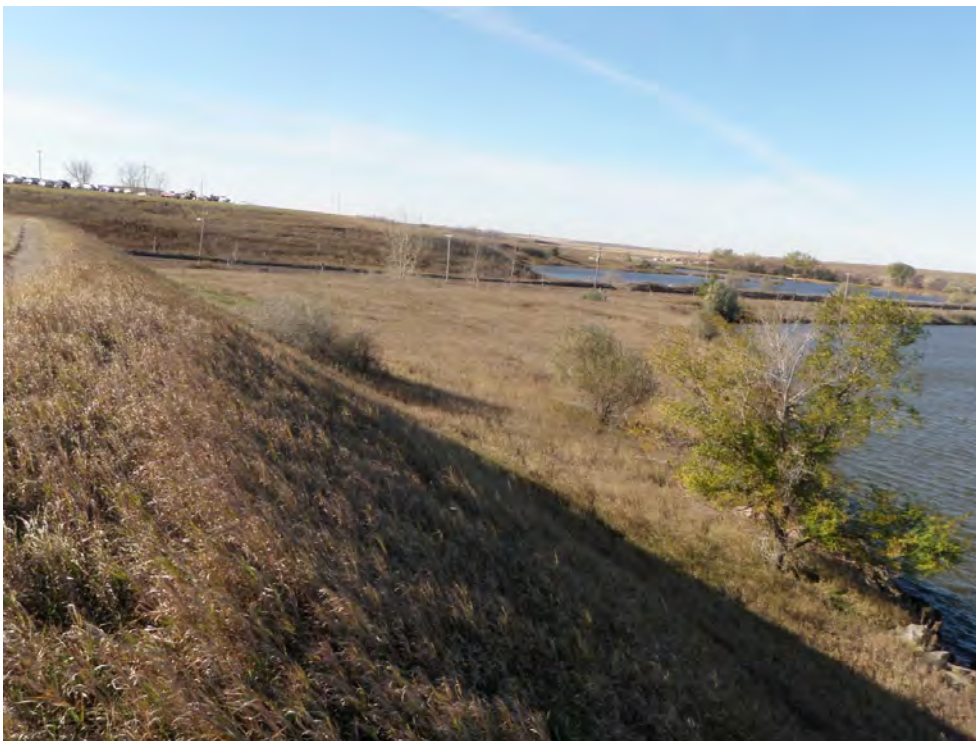
**Photo 8: Alternate Bottom Ash Pond – West dike downstream slope, looking south.**

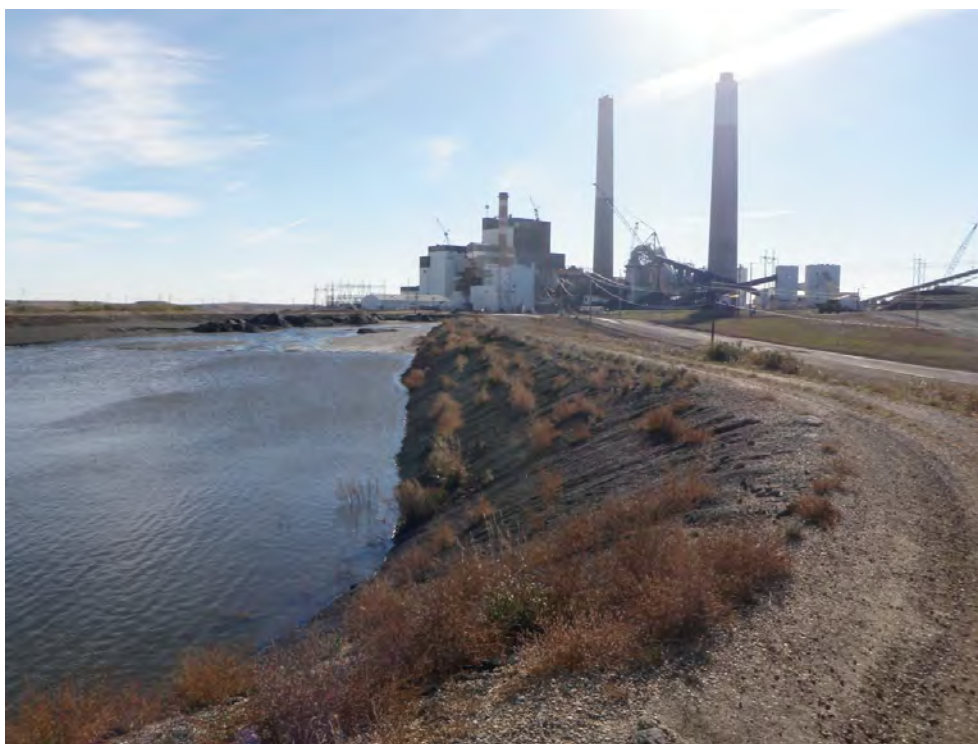
**Photo 9: Alternate Bottom Ash Pond – South dike upstream slope, looking east.**

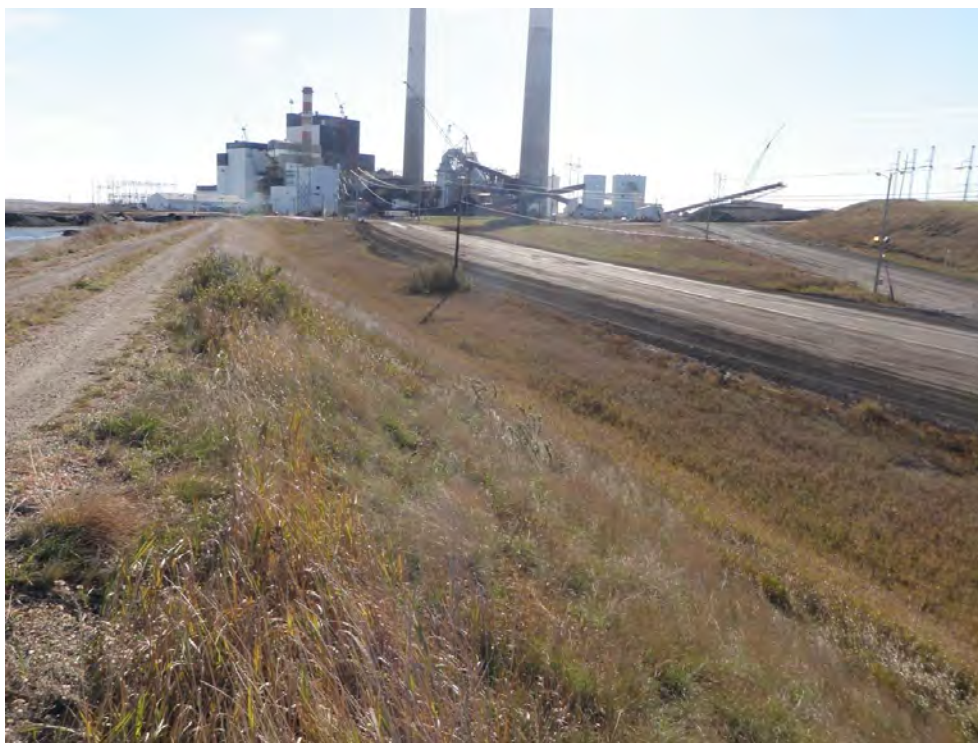
**Photo 10: Alternate Bottom Ash Pond – South dike downstream slope, looking east.**

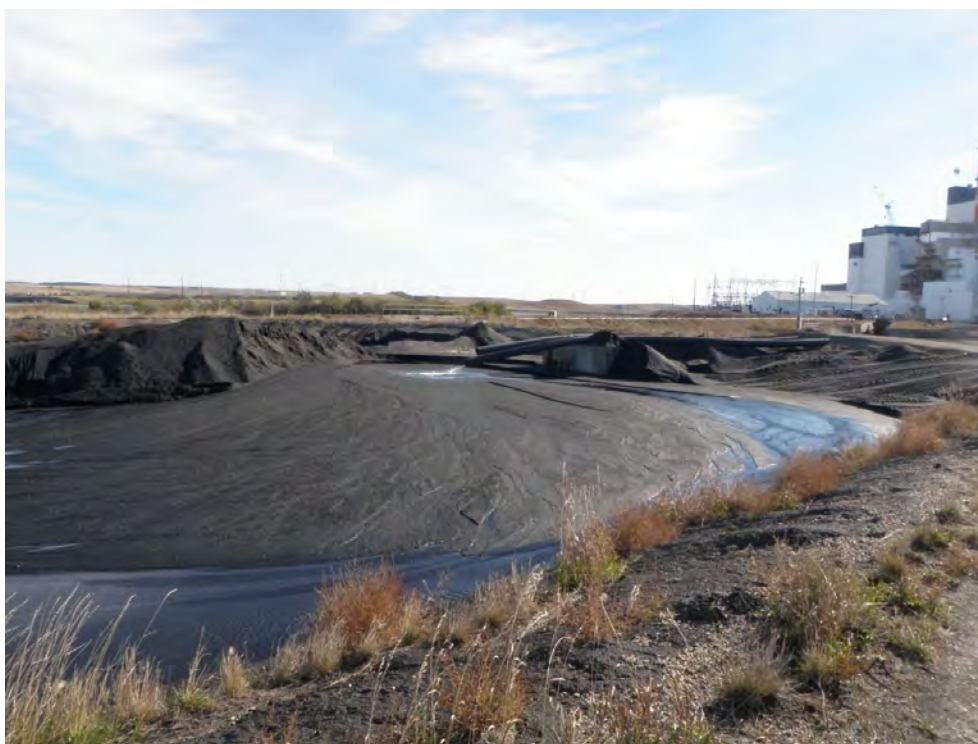
**Photo 11: Alternate Bottom Ash Pond – East dike upstream slope and temporary inlet pipes, looking northeast.**

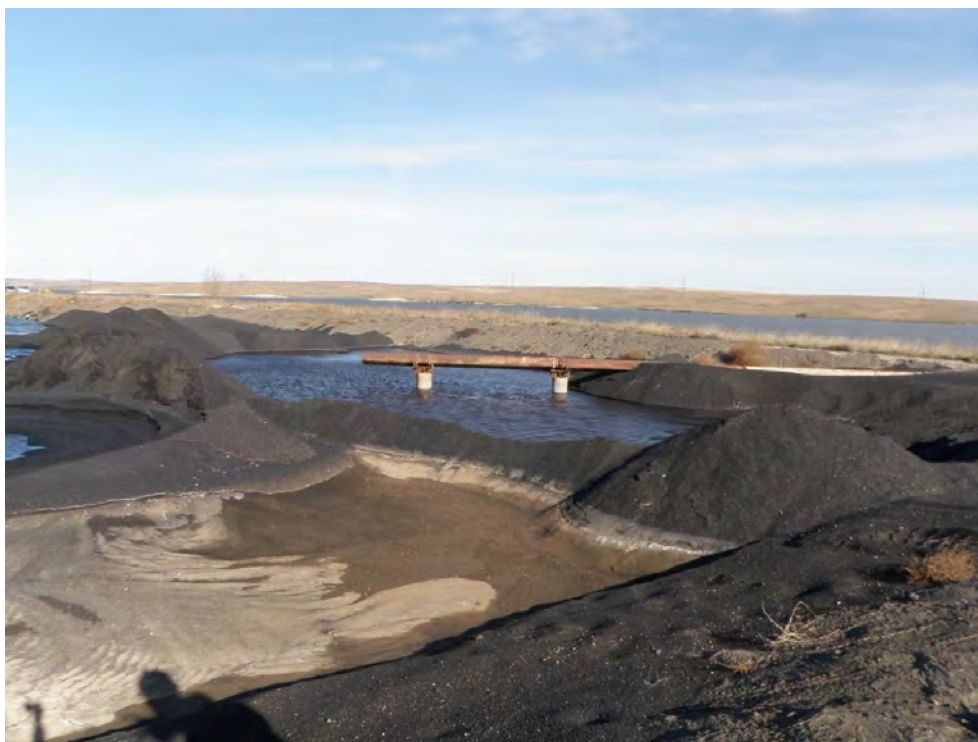
**Photo 12: Alternate Bottom Ash Pond – North dike upstream slope and permanent inlet pipes, looking northwest.**

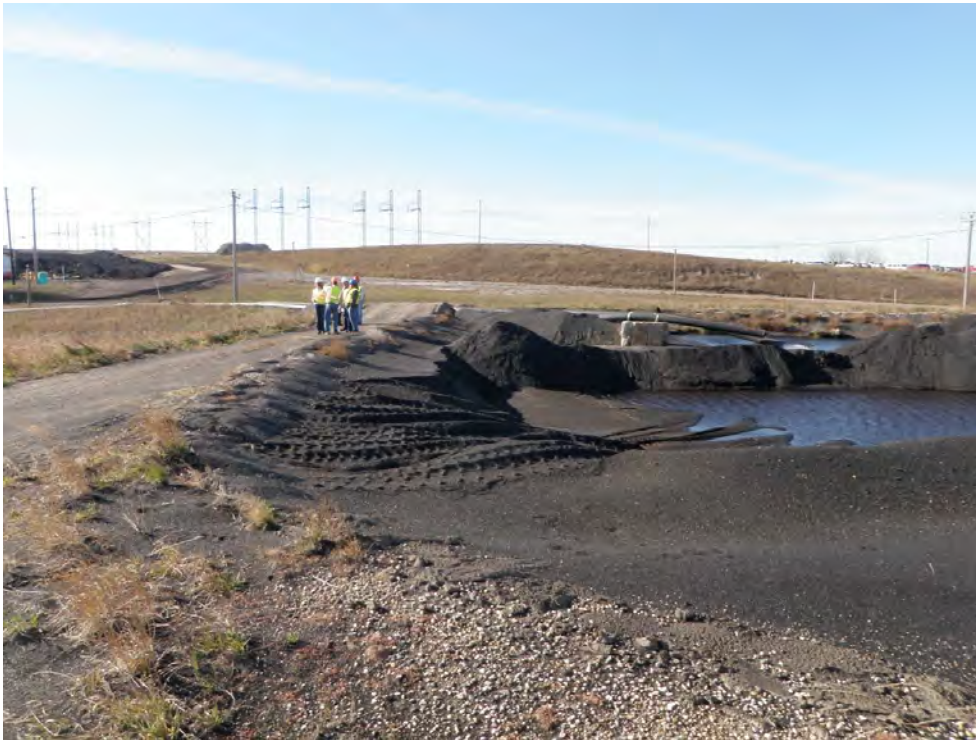
**Photo 13: Alternate Bottom Ash Pond – East dike upstream slope, looking south.**

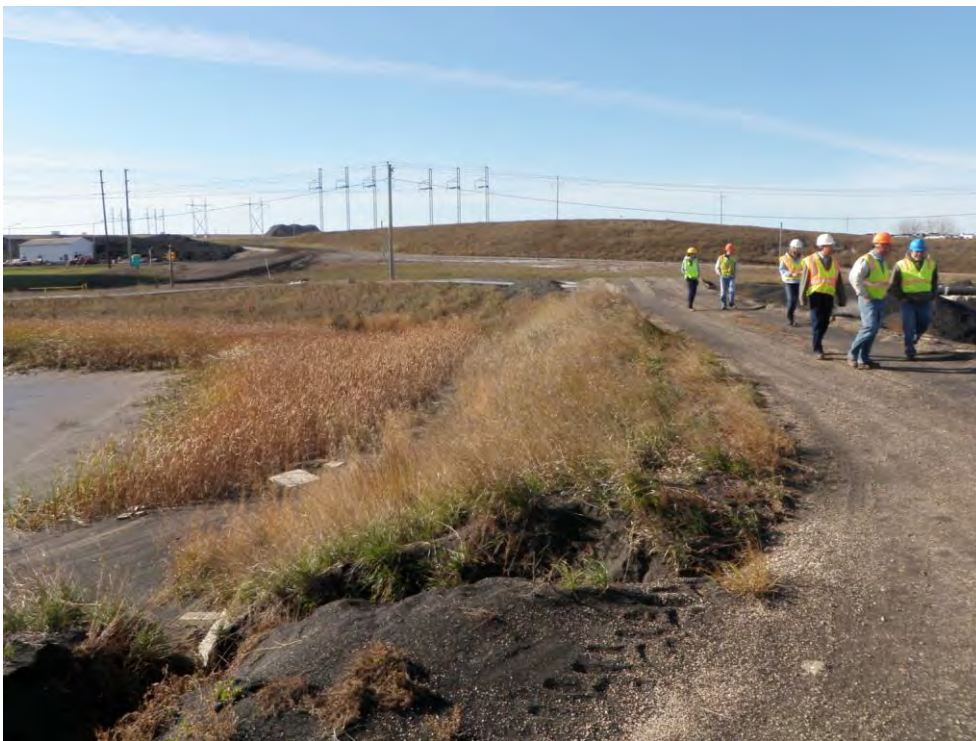
**Photo 14: Alternate Bottom Ash Pond – East dike downstream slope, looking south.**

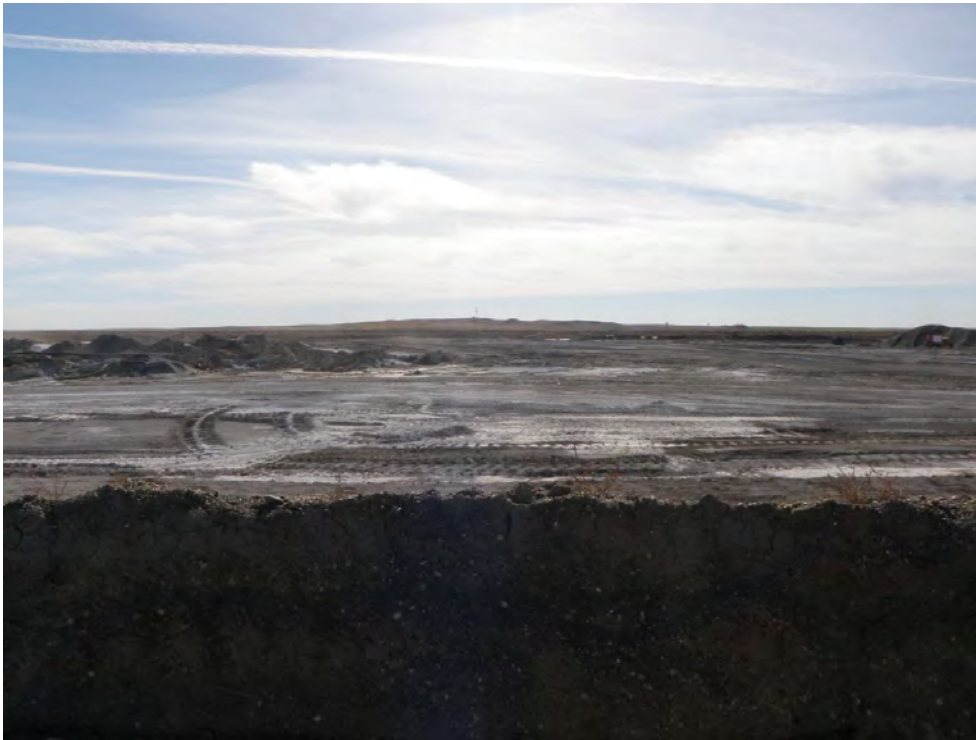
**Photo 15: Cell 1 – Looking south across Cell 1.**

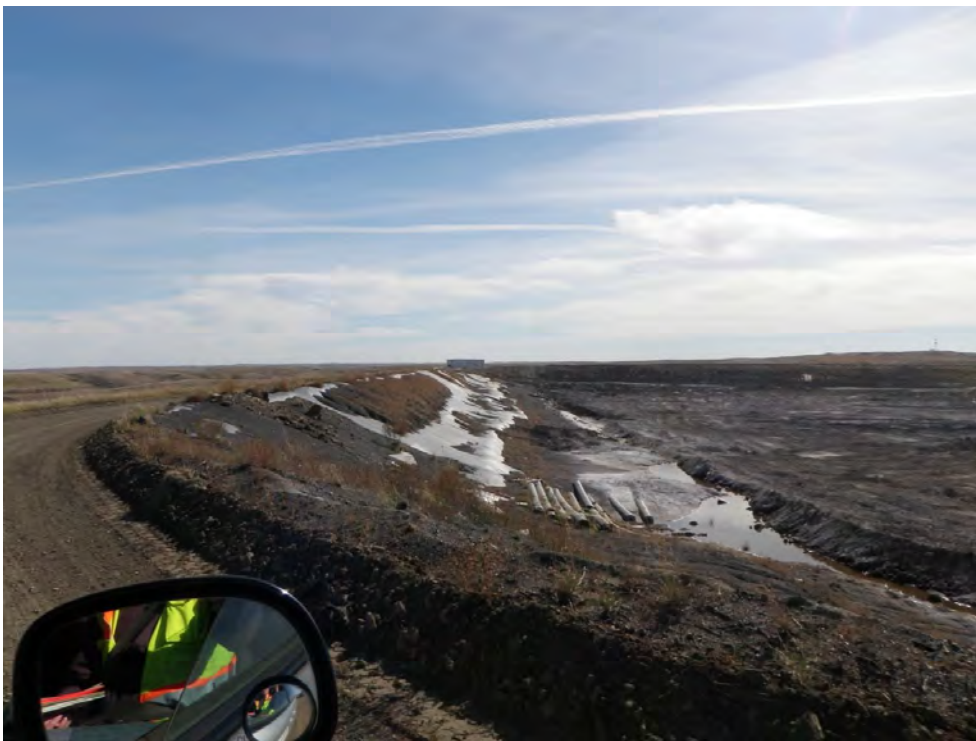
**Photo 16: Cell 1 – East dike upstream slope, looking south.**

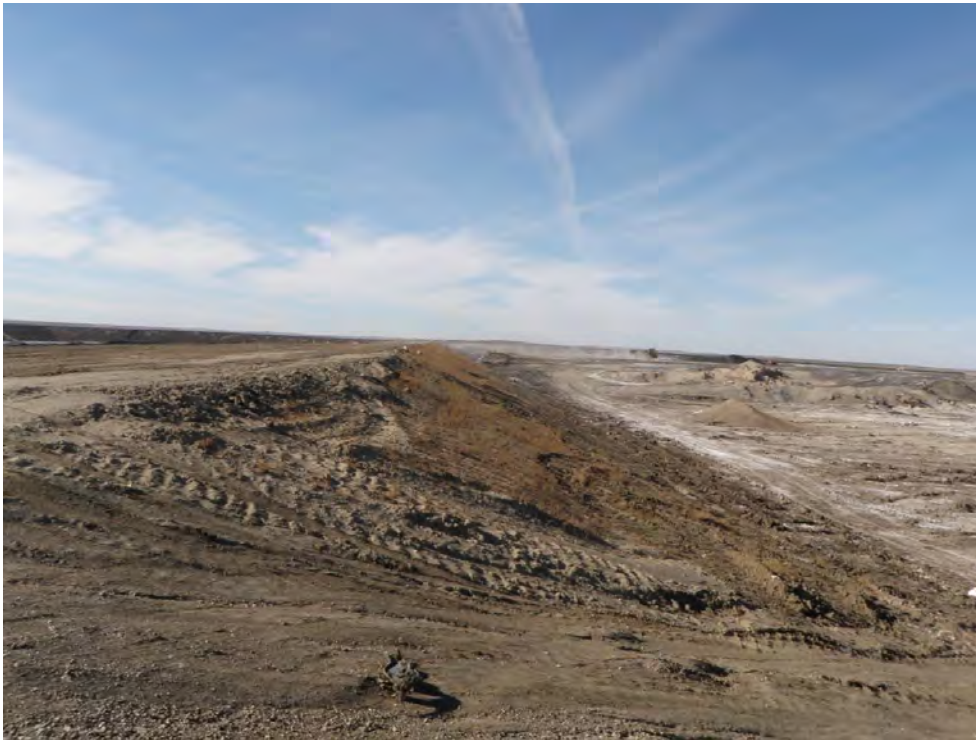
**Photo 17: Cell 1 – South dike upstream slope, looking west, divider dike with Cell 2.**

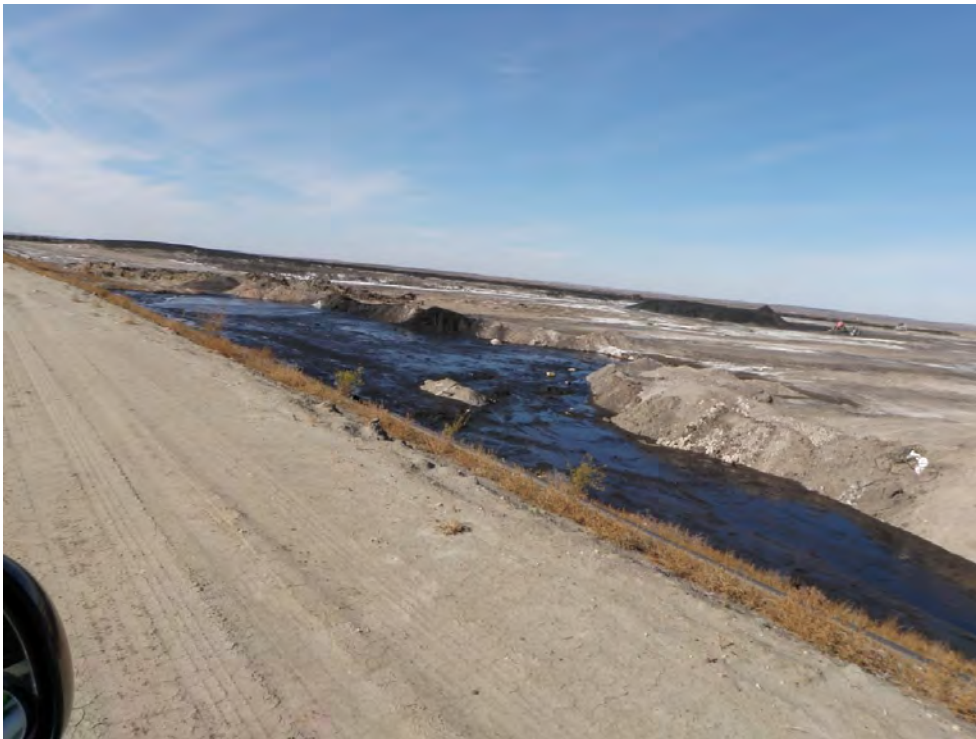
**Photo 18: Cell 1 – Looking northwest across Cell 1.**

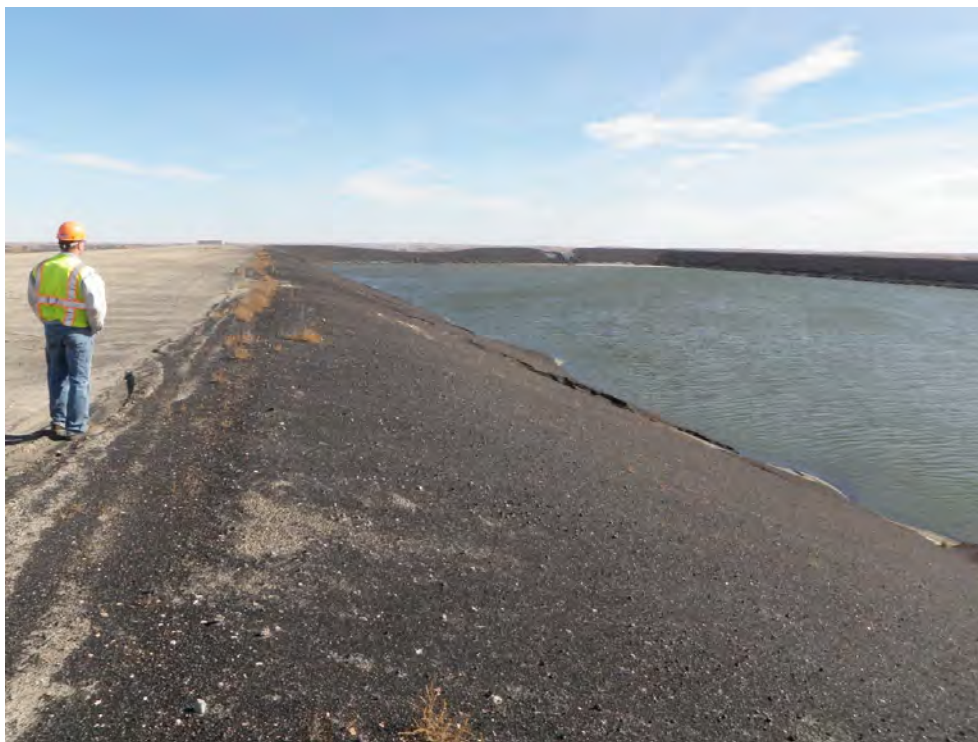
**Photo 19: Cell 2 – North dike upstream slope, looking east, divider dike with Cell 1.**

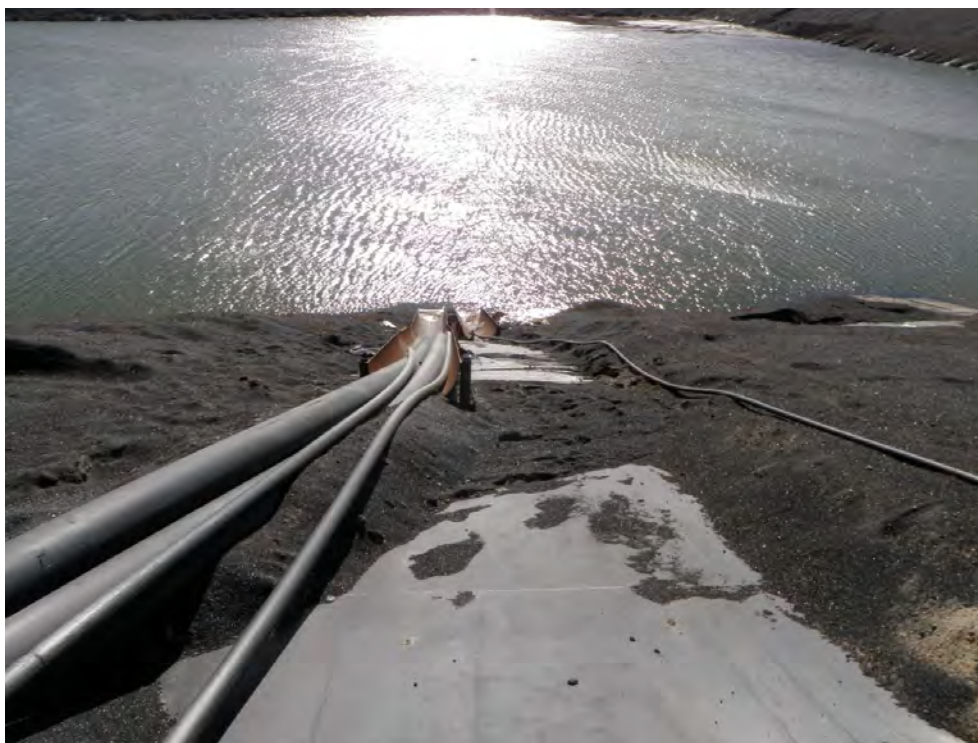
**Photo 20: Cell 2 – North dike upstream slope, looking south, inlet pipes from Unit 1 and leachate collection from Butterfly Pond and Cell 1.**

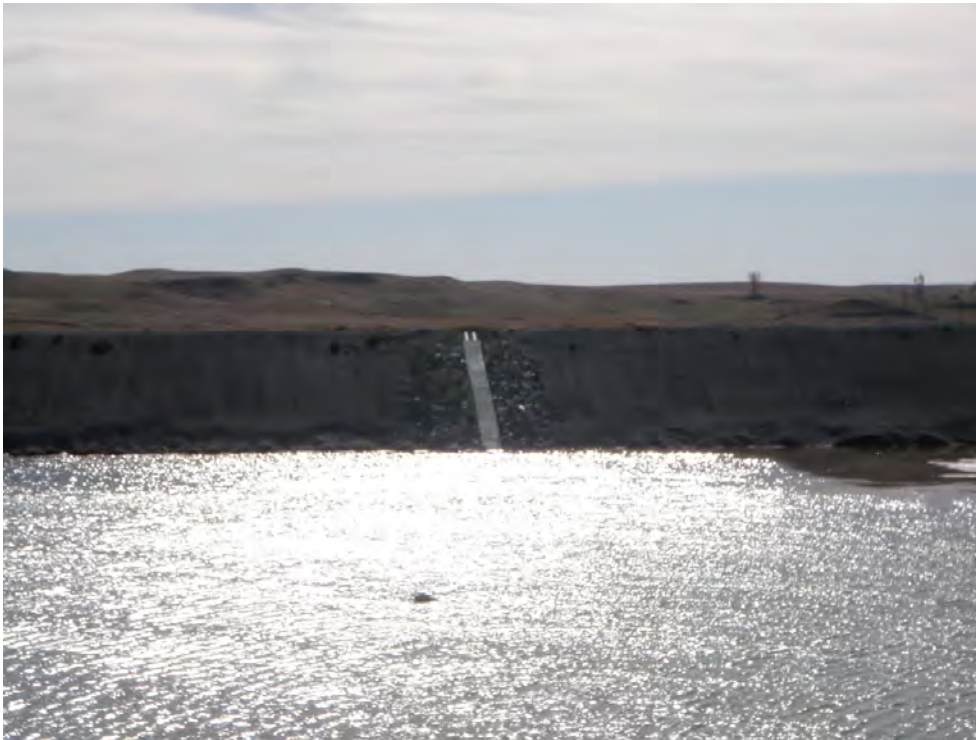
**Photo 21: Cell 2 – South dike upstream slope, looking south, underdrain/leachate pipes for Cell 2.**

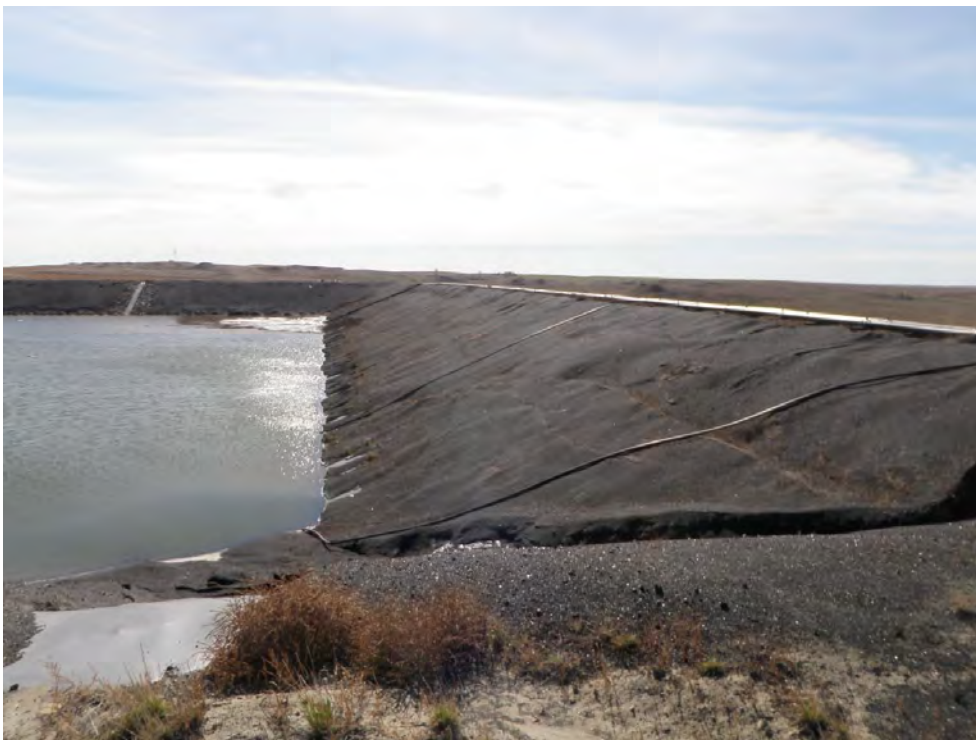
**Photo 22: Cell 2 – West dike upstream slope, looking south, inlet pipes from Unit 2.**

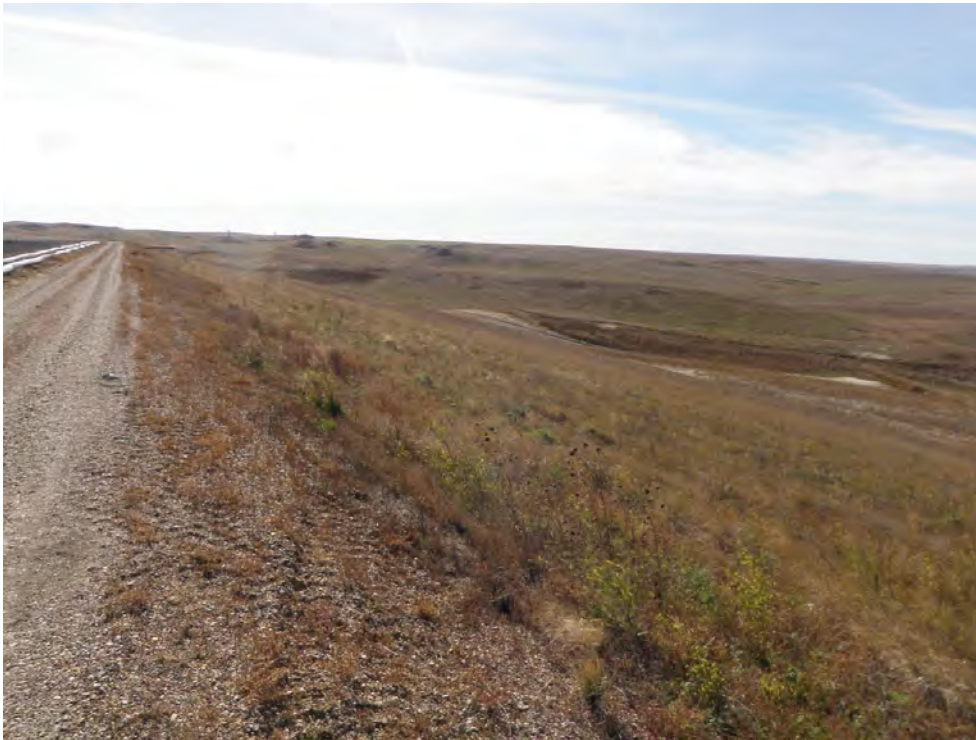
**Photo 23: Cell 2 – West dike downstream slope, looking south.**

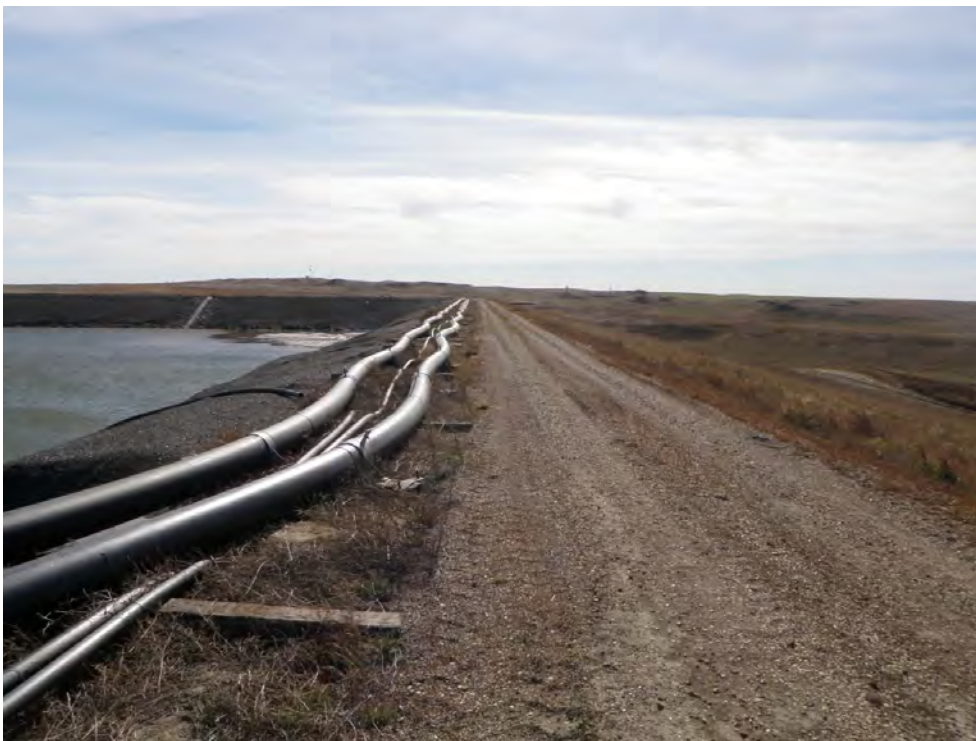
**Photo 24: Cell 2 – West dike crest, looking south, inlet pipes from Unit 2.**

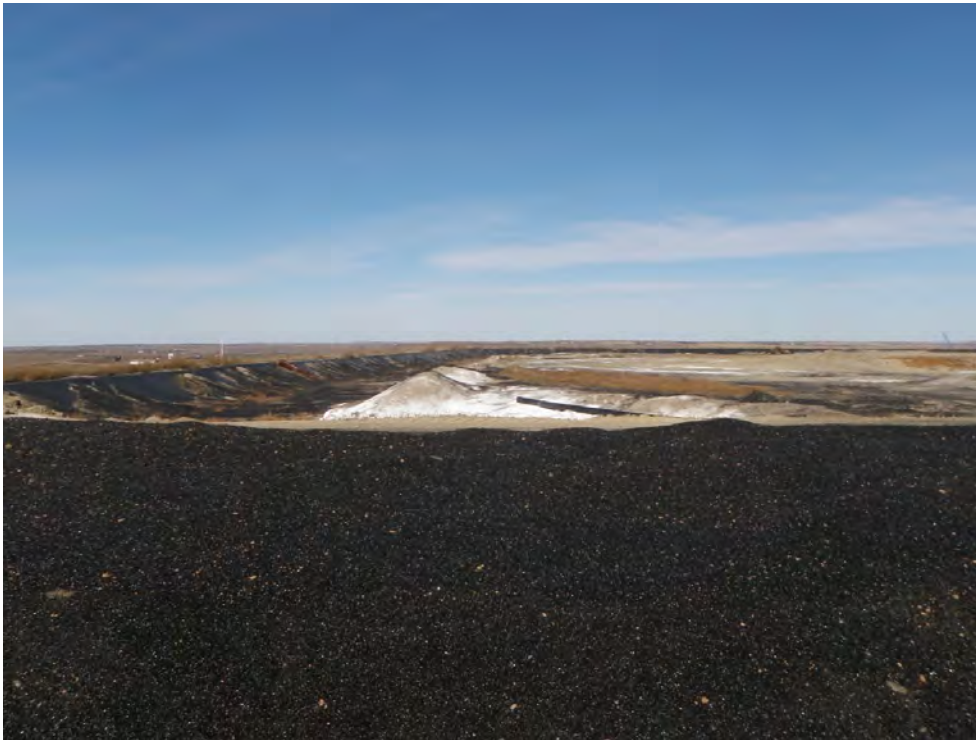
**Photo 25: Cell 1 – West dike upstream slope, looking north.**

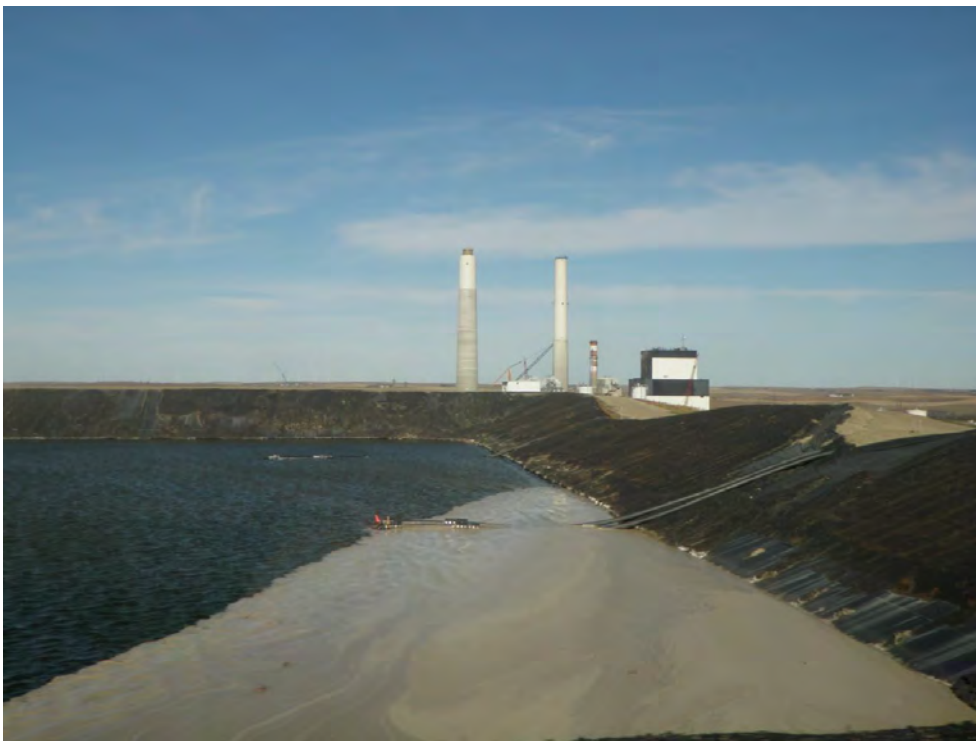
**Photo 26: Cell 2 – East dike upstream slope, looking north, note siphon outlet pipes.**

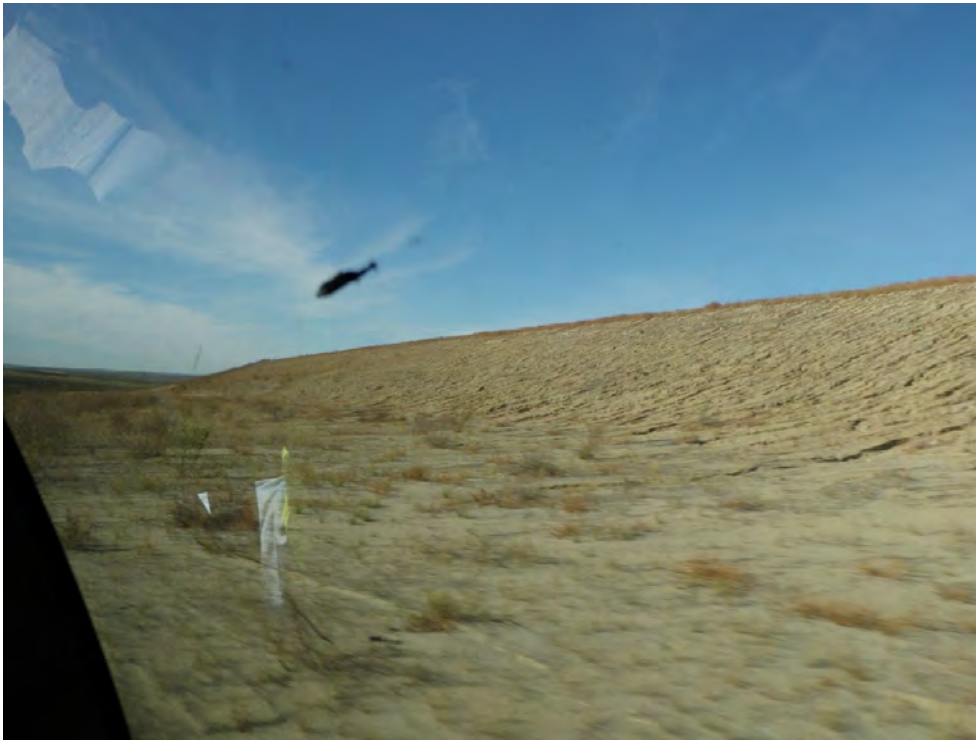
**Photo 27: Cell 2 – South dike downstream slope, looking northwest.**

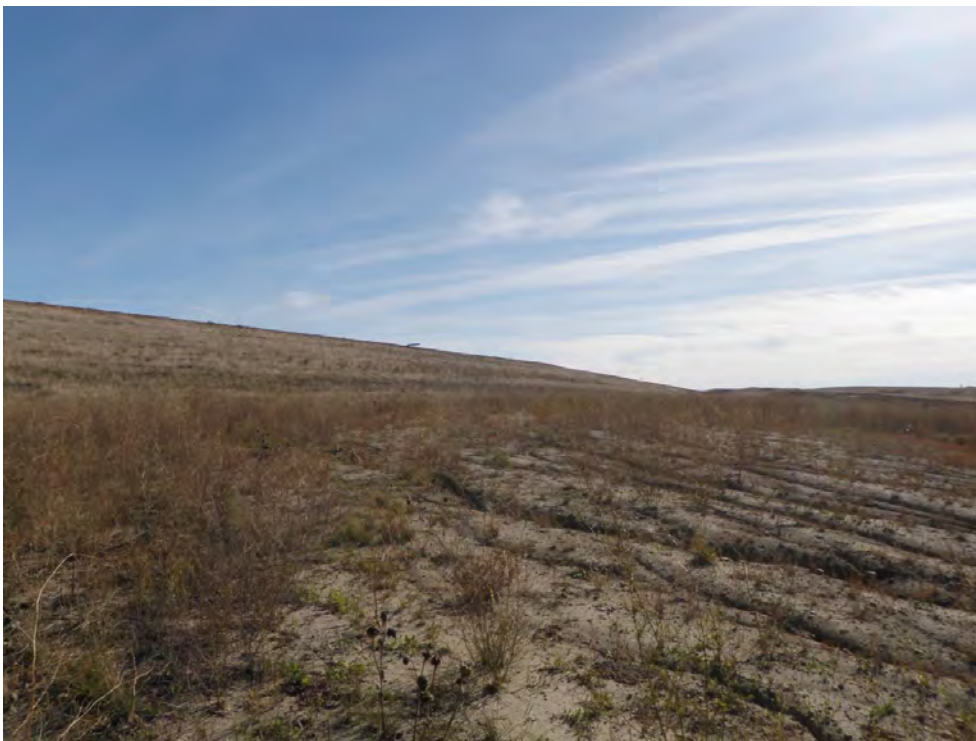
**Photo 28: Cell 2 – West dike downstream slope, looking south.**

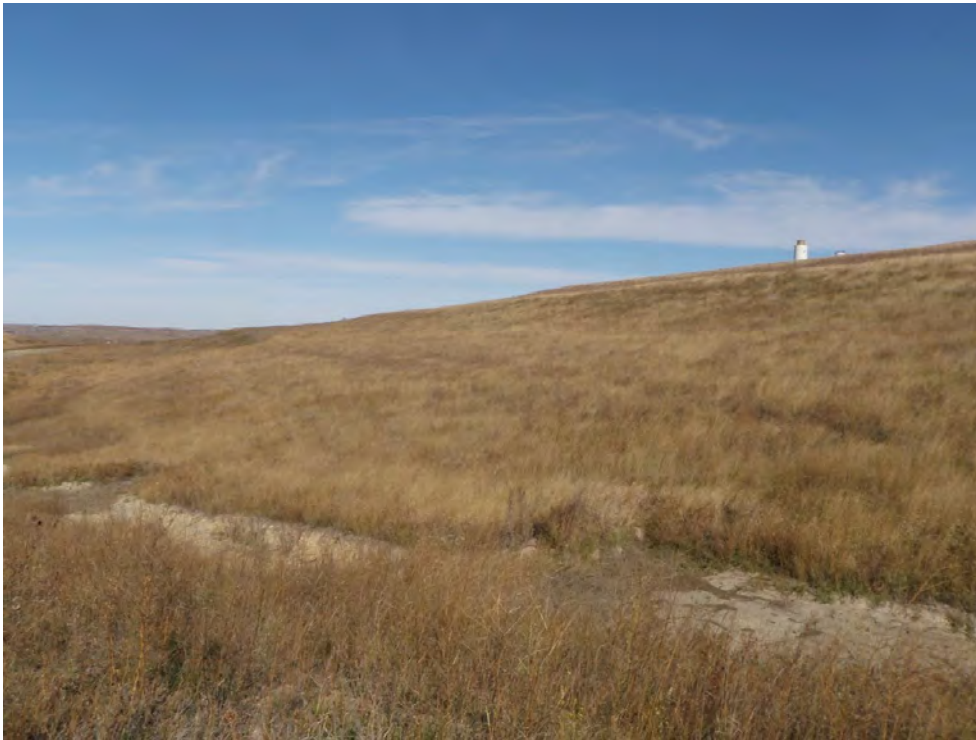
**Photo 29: Cell 1 – West dike downstream slope, looking north.**

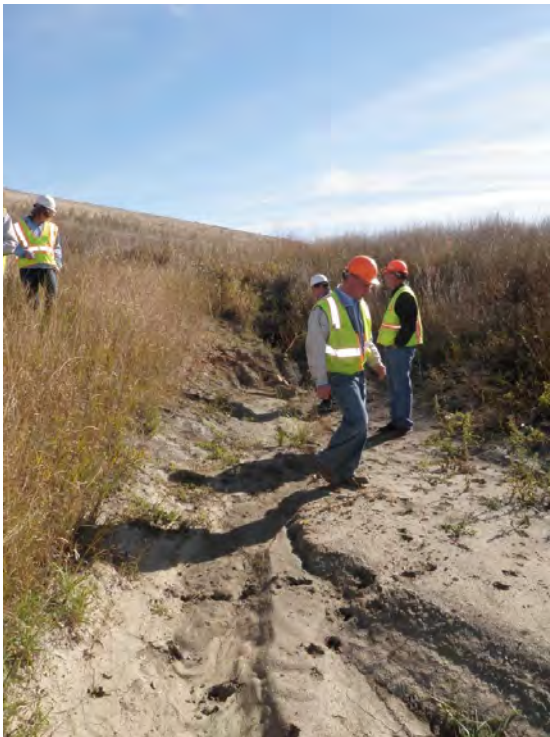
channel was observed near the west embankment downstream toe of Cell 1. The channel appears to have eroded due to surface runoff (see Photo 30) and is not significant enough at this time to impact Cell 1.

No visual signs of instability, movement or seepage were observed. Adequate erosion protection was observed on the embankment slopes of the ash ponds. An erosion channel was observed near the west embankment downstream toe of Cell 1 and minor erosion was observed on the upstream slope protection of the Alternate Bottom Ash Pond and Cell 2. The erosion channel near Cell 1 appears to have eroded due to surface runoff. Minnkota personnel should monitor the channel for continued erosion that could encroach on the west embankment downstream slope of Cell 1.

**Photo 30: Cell 1 – Erosion channel near west dike downstream toe, looking south.**

1. Continue to monitor the erosion channel located near the west embankment downstream toe of Cell 1 to ensure the erosion does not affect the west embankment downstream slope.
2. Perform a slope stability analysis for the Alternate Bottom Ash Pond.
3. Perform a hydrologic analysis of the Milton R. Young Station site and the three CCW impoundments to verify the adequacy of the pond volumes to store the direct precipitation from the inflow design flood. A dam break analysis should be performed for Cell 1 and Cell 2 to evaluate whether significant erosion damage to Nelson Lake Dam would result in the event of dam breach of Cell 1 or Cell 2.

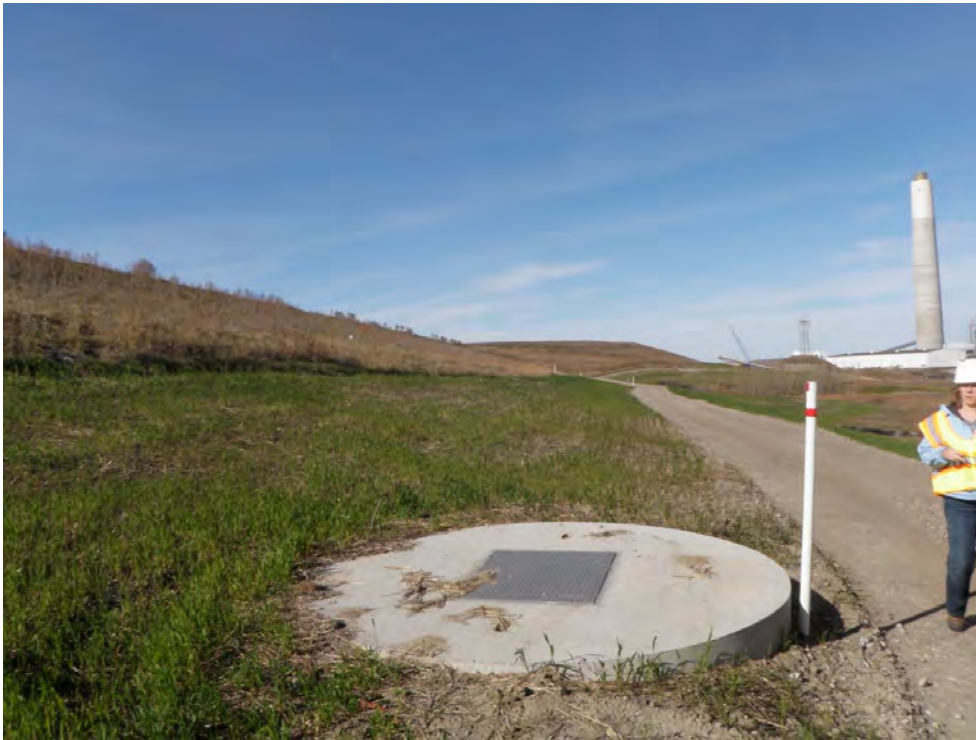
**Photo 31: Cell 1 – East dike downstream slope and manhole for outlet pipes from Cell 2 returning to plant, looking north.**
